**DMC**  
GROUP  
Contractors Ltd

**Welcome to DMC Group**  
Enabling Works, Demolition, Dilapidation,  
Building, Refurbishment & Cladding Specialists.

## Cladding Division Case Study / Salix Court, Salford / Rainscreen & Floor Spanning System.

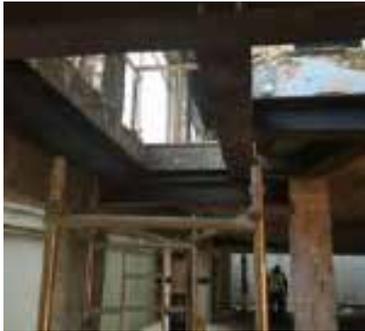
### Structural Steels

In the basement area, DMC were required to remove a safe deposit room and make good any openings left including the concrete floor. There was also a strong room located in the basement and 2 staircases accessing the basement from the ground floor. During these works, we were required to install structural steel beams to ensure that the original bearing capacity was achieved.

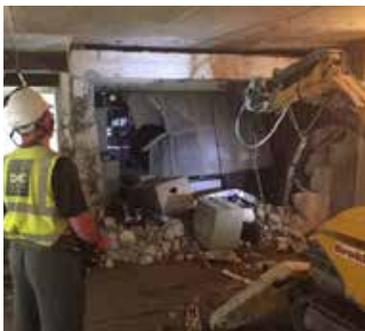
### Basement Works

Due to height restrictions in this area and minimal access, DMC employed the use of a BROKK excavator. The use of this specialised equipment meant that removal works could be carried out within the low ceiling height, effectively and efficiently.

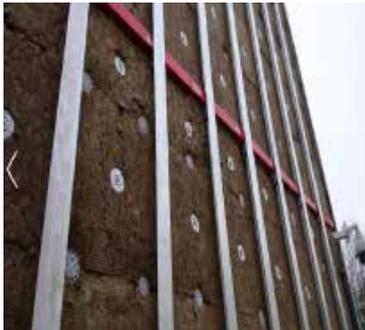
**This floor spanning over cladding system was supplied by System Building Products and installed on location by DMC Group.**

The design has been carried out Mark Heywoods Associates in accordance with British standard codes on wind loading, Structural use of aluminium, corrosion at bimetallic contacts and method of testing for structural fixings.

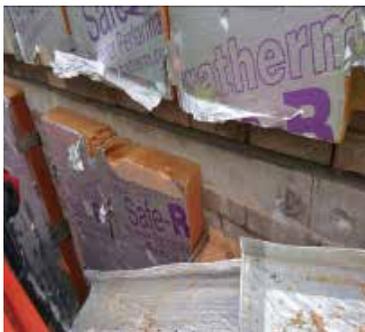
Work commenced by removing Reynabond pannels from the gable end of Salix Court. Once the task had been completed the operatives then began to remove each T rail from the carrier system along with insulation and fire break to expose the buildings brick work. Any historic penetrations in the brick substrate were then injected with EPDM sealant to protect the structure from water and air ingress.

Dead load brackets were then installed using Fischer FIS V 360s resin and stainless steel A40-70 Threaded rod. Brackets were then installed at designed increments to first floor slab along with helping hand brackets to the second-floor slab.

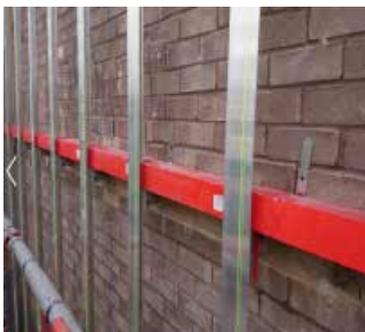
Teflon coated fixings and washers were used on the systems components to reduce friction and provide isolation between dissimilar materials.

Once the installation of the T rails to the brackets had been completed operatives lined and levelled the grid before installing Tenmat Ventilated Fire Barrier at floor slab level.

A constant 30mm air gap was maintained between the intumescent strip and the back of the support rail to allow for free air flow with in the compartments.

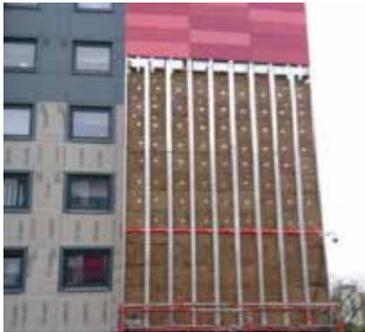
Once installation of the Fire break had been completed operatives then began installing 110mm Knauf Earthwool Dritherm Cavity Slab to the brick substrate. The insulation was then directly fixed to the building using 6 number plastic tie back fixings with spreader washer and 2 number stainless steel fire rated insulation fixings.

An expansion joint has been installed at every second level to allow for deflection of the internal slab or expansion and contraction of the façade system.
